**PROJECT LOCATION:** Executive Center | North Carolina

**DATE OF PROJECT:** September, 2016

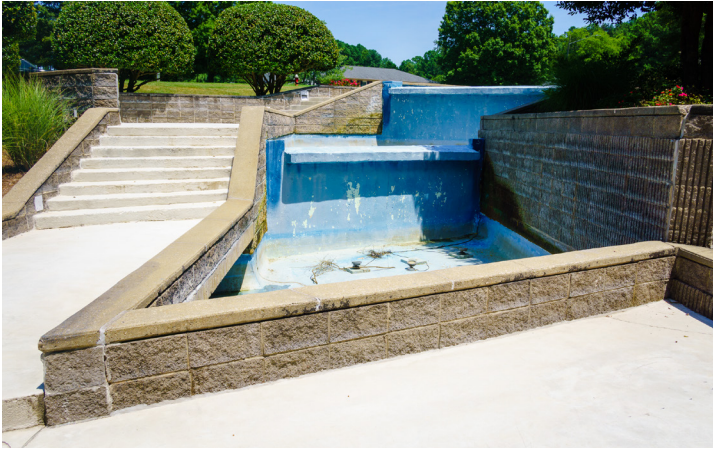
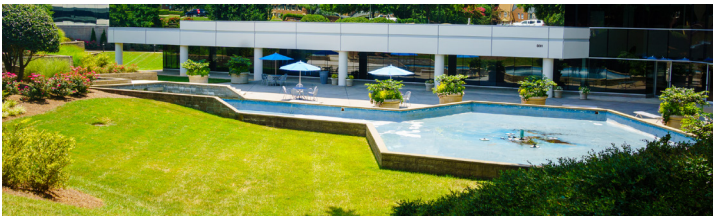
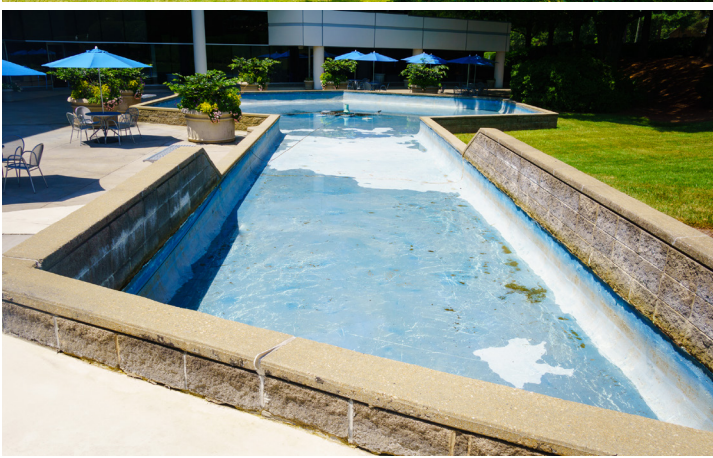
Before

The previous lining that was used for the Executive Center fountain was in dire need of replacement. The concrete was not properly prepped for the lining, which ended up contributing to the linings short life span. The concrete had areas with cracks that needed to be patched, and on the inner walls of the fountain, spalls and bug holes were not properly filled. All of these factors, along with the selected linings chemistry, led to the lining cracking and delaminating in many areas. This left the beautifully architected fountain with a worn down, undesirable look.

The contractor carefully inspected the fountain and Wolverine Coatings Corporation's products were specified for this job due to their durability and longevity. To remove the previous epoxy lining, the crew used a diamond blade concrete grinder on the fountain floors, and a hand held diamond blade grinder on the walls and corner surfaces. To repair the concrete, **IntegraFlex 1922** was used on any vertical surface that had spalls, cracks, or bug holes that needed patching. **IntegraFlex 1921** was used to repair cracks on the horizontal surfaces. Once cured, any high spots were then leveled with a grinder. After the substrate had been properly repaired, the crew applied a 15 mil flood coat of **BondTite 1101 Primer** to the fountain floor, and 12 mils to the walls. The primer flood coat also aided in smoothing out any uneven areas on the surface. **LiquaTile 1187** protective epoxy lining was then applied overtop of the primer at 25 mils using a squeegee and roller brush. Once the base coat cured, an additional coat of **LiquaTile 1187** was again applied at 25 mils as the top coat.

1. All pool surfaces to be coated received diamond blade concrete grinders on pool floors and handheld diamond blade on wall/corner surfaces.
2. IntegraFlex 1921: Crack filler for horizontal surfaces
3. IntegraFlex 1922: Cracks and bug hole patching for vertical surfaces.

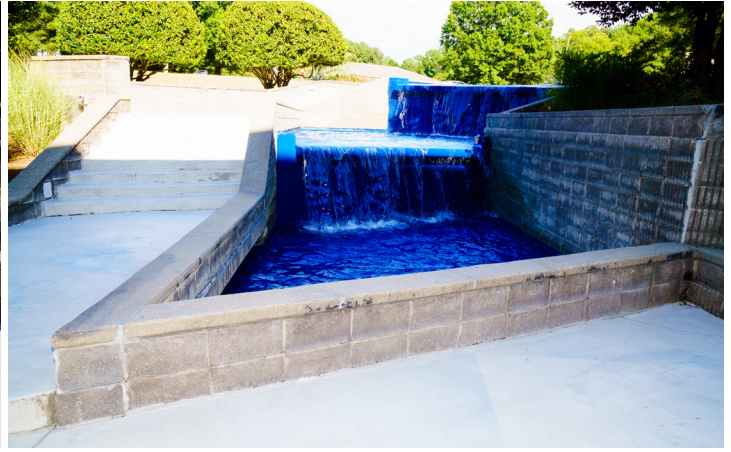
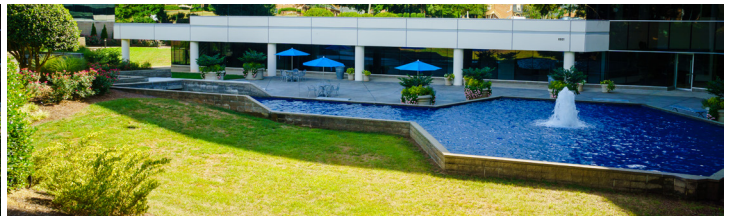
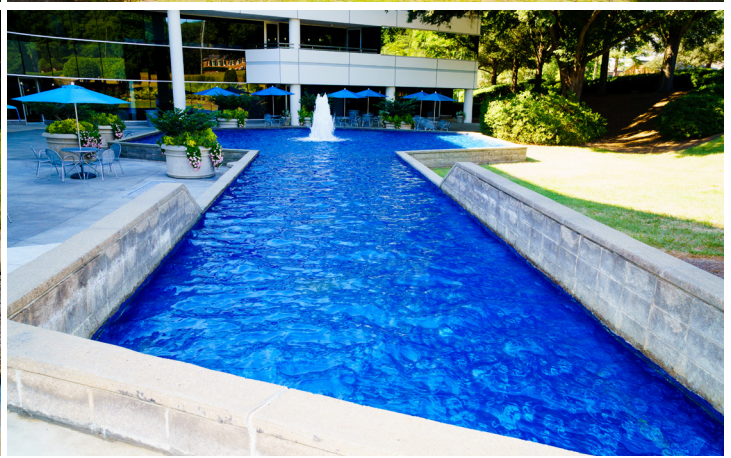
After

The finished fountain lining has excellent resistance in aquatic environments, while also displaying outstanding mechanical properties, such as adhesion and abrasion resistance. The primer's advanced penetration paired with its robust adhesion to concrete provided an excellent foundation for the lining system. With standard maintenance, this lining system has the ability to keep this fountain looking great for years to come.

1. Primer: BondTite 1101 - Applied at 15 mils
2. Base Coat: LiquaTile 1187 - Epoxy Lining for aquatic environments - Applied at 25 mils
3. Top Coat: LiquaTile 1187 - Epoxy Lining for aquatic environments - Applied at 25 mils
