Case History Report: YMCA Lap Pool

PROJECT LOCATION: YMCA | North Carolina

DATE OF PROJECT: September, 2019

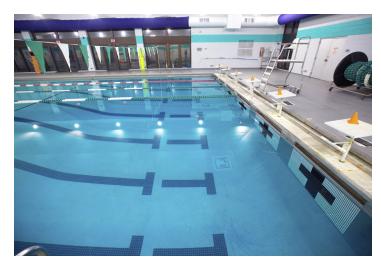
The lap pool was formed by placing and forming a concrete shell in the ground, then troweling a waterproofing Marcite layer over the concrete shell. Unfortunately, the Marcite layer thickness was anywhere between ½" to 2.5" thick, and was deteriorating and peeling in multiple areas. The pool floor and walls were spattered with blemishes from the repeated cleaning of algae. The entire pool's substrate needed to be removed, resurfaced, and recoated.

To remove the pre-existing marcite, the crew used jack hammers, chisels, hammers, and various hand tools. Once the Marcite layer was removed, a cementious based product was troweled over any uneven areas to repair and resurface the pool's concrete shell.

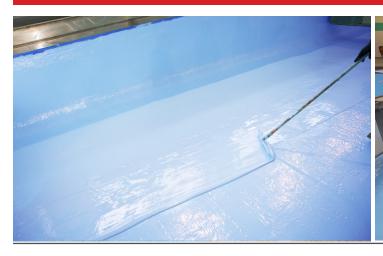
The primer's advanced penetration paired with it's robust adhesion to concrete provided an excellent foundation for the lining system. The pool lining has excellent resistance in aquatic environments, backed by outstanding adhesion and abrasion resistance. Keeping the pool clean will be less troublesome, as the previous tiled swimming lanes that attracted algae buildup were removed and replaced with this seamless system.

After the substrate had been properly repaired and prepared, the crew applied a 15 mil flood coat of **BondTite 1101** Primer to the entire pool's surface. Once the primer had cured, **LiquaTile 1187** protective epoxy lining was then applied at 30 mils using a squeegee and roller brush. An additional coat of **LiquaTile 1187** was again applied at 30 mils as the top coat. Lastly, **LiquaTile 1187** was used for the black lines to denote the swimming lanes.
