**PROJECT LOCATION:** Executive Center | North Carolina

**DATE OF PROJECT:** September, 2016

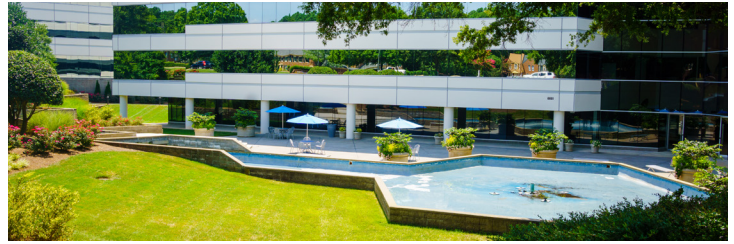
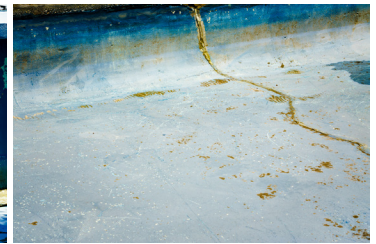
The previous lining that was used for the Executive Center fountain was in dire need of replacement. The concrete was not properly prepped for the lining, which ended up contributing to the linings short life span. The concrete had areas with cracks that needed to be patched, and on the inner walls of the fountain, spalls and bug holes were not properly filled. All of these factors, along with the selected linings chemistry, led to the lining cracking and delaminating in many areas. This left the beautifully architected fountain with a worn down, undesirable look.

The contractor carefully inspected the fountain and Wolverine Coatings Corporation's products were specified for this job due to their durability and longevity. To remove the previous epoxy lining, the crew used a diamond blade concrete grinder on the fountain floors, and a hand held diamond blade grinder on the walls and corner surfaces. To repair the concrete, **IntegraFlex 1922** was used on any vertical surface that had spalls, cracks, or bug holes that needed patching. **IntegraFlex 1921** was used to repair cracks on the horizontal surfaces. Once cured, any high spots were then leveled with a grinder. After the substrate had been properly repaired, the crew applied a 15 mil flood coat of **BondTite 1101 Primer** to the fountain floor, and 12 mils to the walls. The primer flood coat also aided in smoothing out any uneven areas on the surface. **LiquaTile 1187** protective epoxy lining was then applied overtop of the primer at 25 mils using a squeegee and roller brush. Once the base coat cured, an additional coat of **LiquaTile 1187** was again applied at 25 mils as the top coat.
