PROJECT LOCATION: Community College | South Carolina

DATE OF PROJECT: September, 2017

THE CHALLENGE

THE SOLUTION

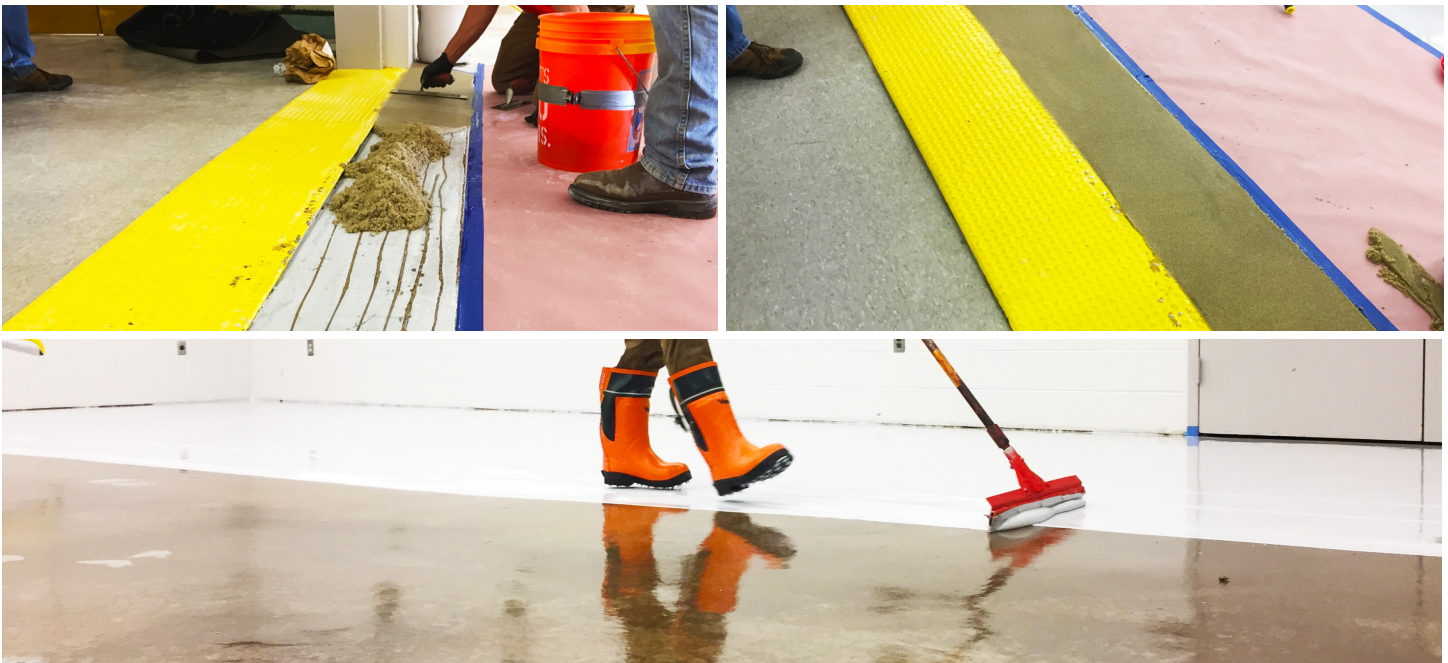
The finished machine shop floor has excellent impact and abrasion resistance. The primer's advanced penetration paired with it's robust adhesion to concrete provided an excellent foundation for the flooring system. The uneven surface underneath the overhead doors were smoothed out and is no longer a tripping hazard. The line demarcations established definitive foot traffic lanes. The aggregate that was added to the sealer coat gave the floor a slip-resistant surface, that is still easily cleanable due to the aggregates round, rather than angular profile.

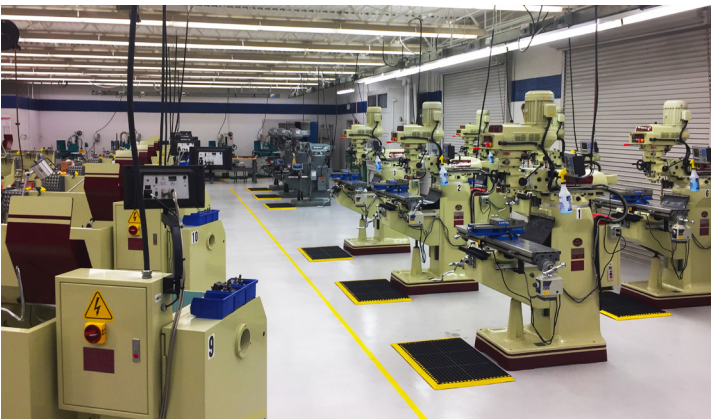
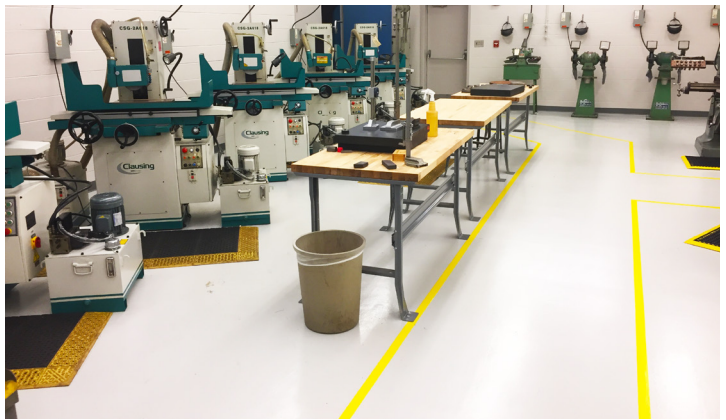
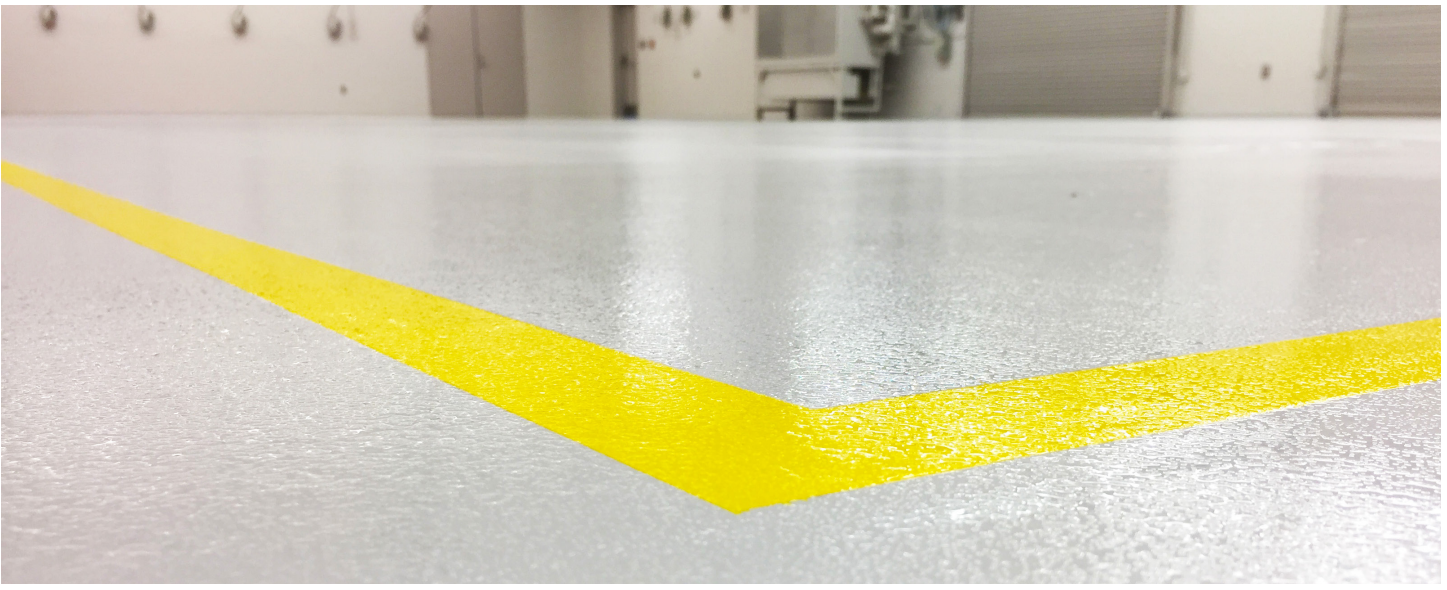
1. All surfaces to be coated received diamond blade concrete grinders.
2. All surfaces to be coated received bushing head concrete grinders.
3. **OilEater 939:** Advanced microbial oil digester to remove oil-based contaminants from substrate.
4. All surfaces to be coated received multiple passes with a pressure washer at 4,000 psi.
5. **TrowelEase 1162 PK:** Patching kit used to resurface ramps beneath overhead doors.

1. **Primer: BondTite 1101** - Applied at 10 mils
2. **Base Coat: LiquaTile 1143** - Full Ceramic Epoxy Floor Coating - Applied at 25 mils
3. **Top Coat: LiquaTile 1143** - Full Ceramic Epoxy Floor Coating - Applied at 25 mils
4. **Safety Lines: LineGevity 1382** - Self leveling polymer designed for the application of lines - Applied at 5 mils
5. **Sealer Coat: EnduraShield 2254** - Clear gloss urethane with SpheriTex 110 added for slip resistance - Applied at 5 mils
